RAM9 QDR-I/DDR-I/QDR-II/DDR- II Errata

This document describes the $\overline{\text{DOFF}}$ issue for QDRII/DDR II and the Output Buffer and JTAG issues for QDR I/DDRI/QDR II/DDR II. Details include trigger conditions, possible workarounds and silicon revision applicability. This document should be used to compare to the respective datasheet for the devices to fully describe the device functionality.

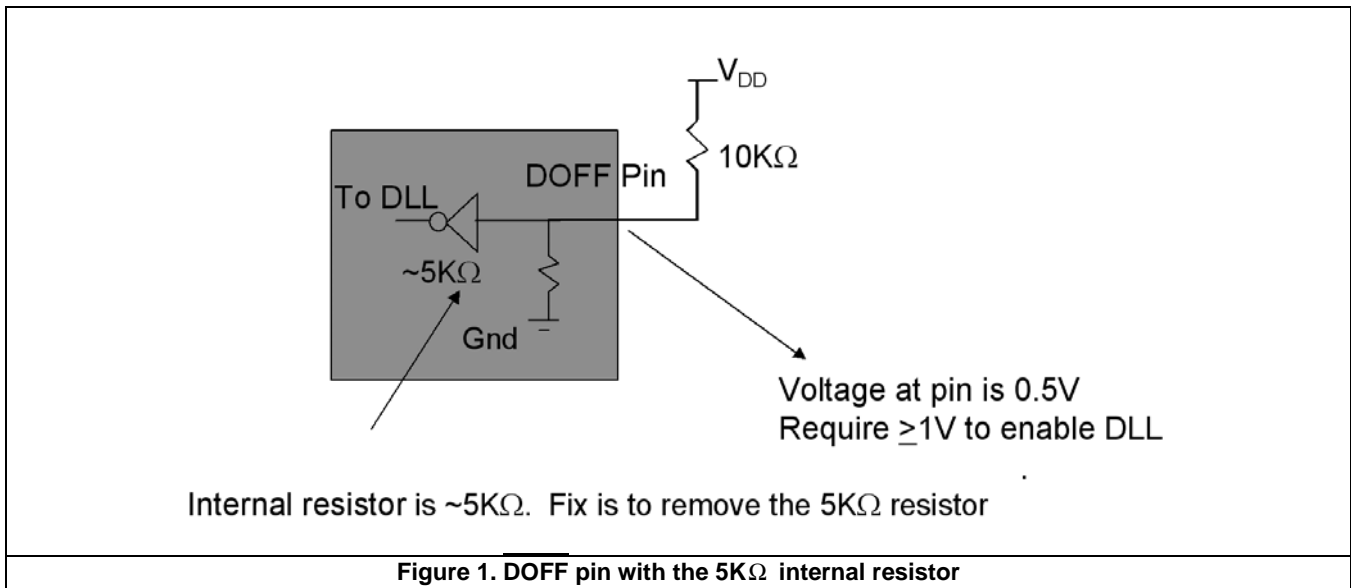
This issue involves the DLL not turning ON properly if a large resistor is used (eg:-10K Ω) as an external pullup resistor to enable the DLL. If a 10K Ω or higher pullup resistor is used externally, the voltage on DOFF is not high enough to enable the DLL.

Figure 1 shows the DOFF pin circuit with an internal 5K Ω internal resistor. The fix planned is to disable the internal 5K Ω leaker.

Fix involved removing the internal pull-down resistor on the $\overline{\text{DOFF}}$ pin. The fix has been implemented on the new revision and is now available. The new revision is an increment of the existing revision. The following table lists the devices affected, current revision and the new revision after the fix.

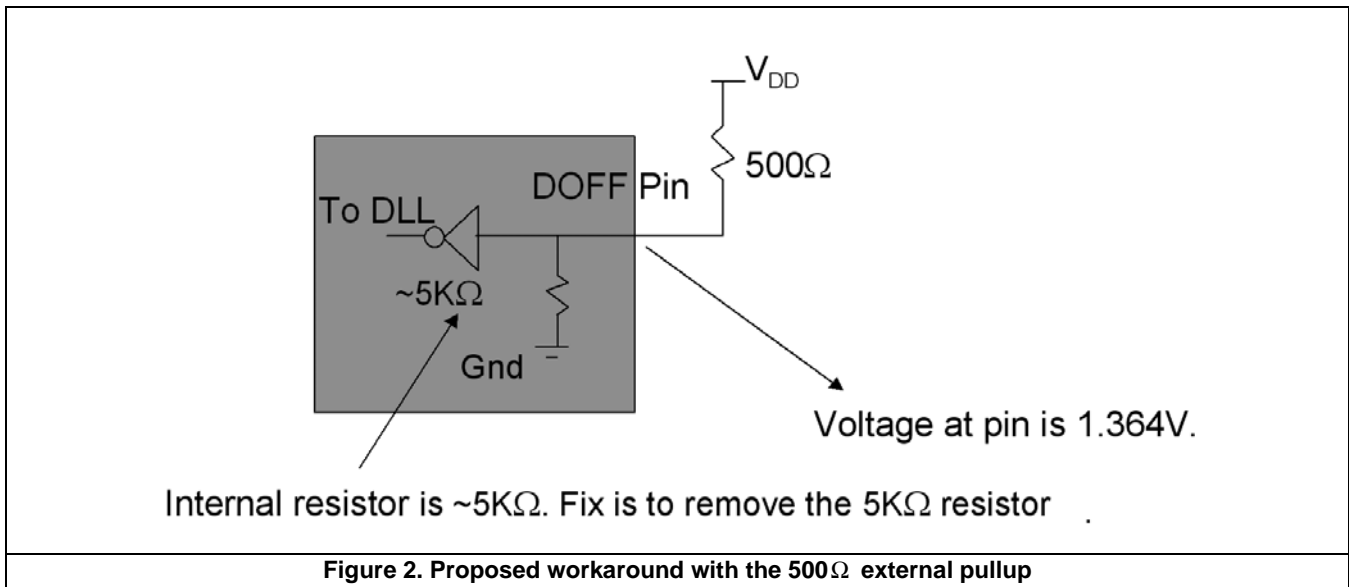
Figure 2 shows the proposed workaround and the fix planned.

The workaround is to have a low value of external pullup resistor for the $\overline{\text{DOFF}}$ pin (recommended value is $\leq 500\Omega$). When $\overline{\text{DOFF}}$ pins from multiple QDR devices are connected through the same pull-up resistors on the board, it is recommended that this $\overline{\text{DOFF}}$ pin be directly connected to V_{DD} due to the lower effective resistance since the "leakers" are in parallel.
